# Manhole Inspection Summary

Manhole # S31AA\_001MH

Insp Date: **12/19/07 4:40 AM**

**Location** Address: **900 MLK JR BLVD**

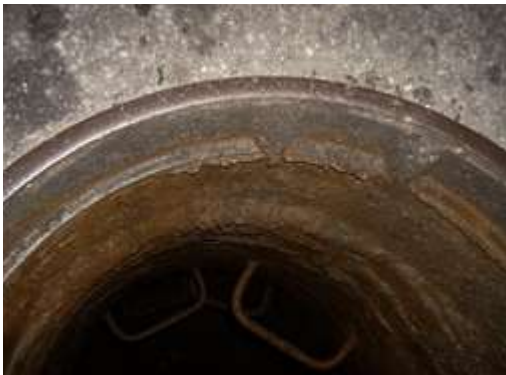
Defect 1

Offset: **0.5** (in.)

FRAME OFFSET

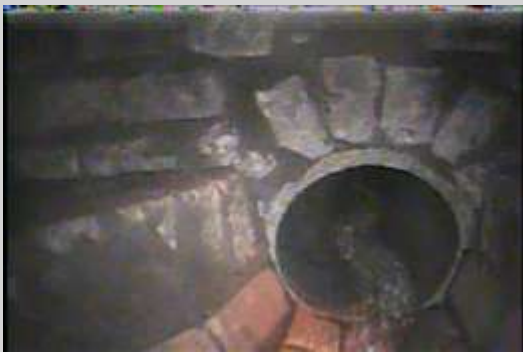
12 O'Clock Outflow

8 in. Circular Gravity Sewer  
Pipe Out @ 12 O'Clock

Pipe Height: **8.4** (in.) Rod and Bar (Angled)  
Pipe Material: **Clay** ☐ Pipe Lined  
Invert Depth: **10.76** (ft.) Flow Characteristics: **Slow**  
Deposits: ☒ None ☐ Mud ☐ Sludge ☐ Debris ☐ Grease  
Silt Depth: (in.) Deposits Extent:  
Infiltration: **None** Pipe Seal Cond: **Sound**

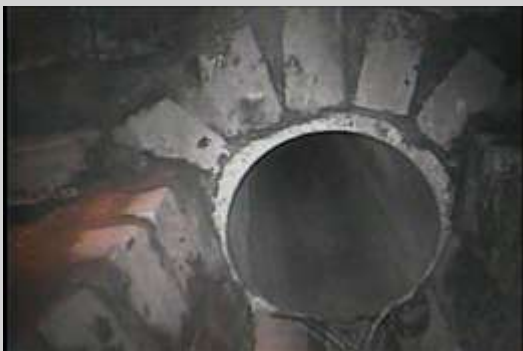
3 O'Clock Inflow

8 in. Circular Gravity Sewer  
Pipe In @ 3 O'Clock

Pipe Height: **8.4** (in.) Rod and Bar (Angled)  
Pipe Material: **Clay** ☐ Pipe Lined  
Invert Depth: **10.31** (ft.) Flow Characteristics: **Slow**  
Deposits: ☒ None ☐ Mud ☐ Sludge ☐ Debris ☐ Grease  
Silt Depth: (in.) Deposits Extent:  
Infiltration: **None** Pipe Seal Cond: **Sound**

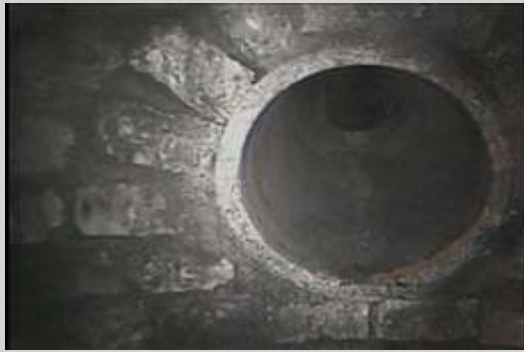
9 O'Clock Inflow

FRAME OFFSET

Pipe Height: **7.2** (in.) Rod and Bar (Angled)

Drop: **Outside** Rod and Bar
